# CCGP **Issue #2** REVIEW

For QSD and QSP Registration and Renewal

# Enforcement Case Study

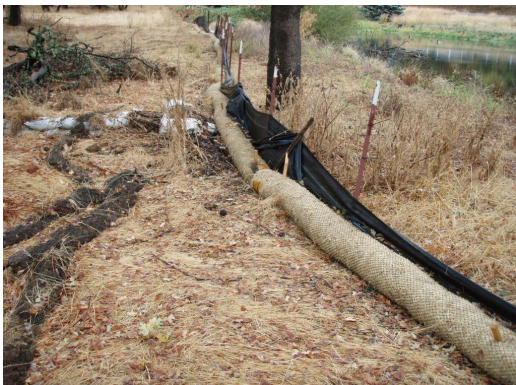
Figure 1

Photos from an inspector show that permit conditions are not met. The first issue was poorly maintained BMPs. The photo in Figure 1, taken on October 22, shows wattles used as perimeter control, but the silt fence is in disrepair and other BMPs are clearly not maintained.

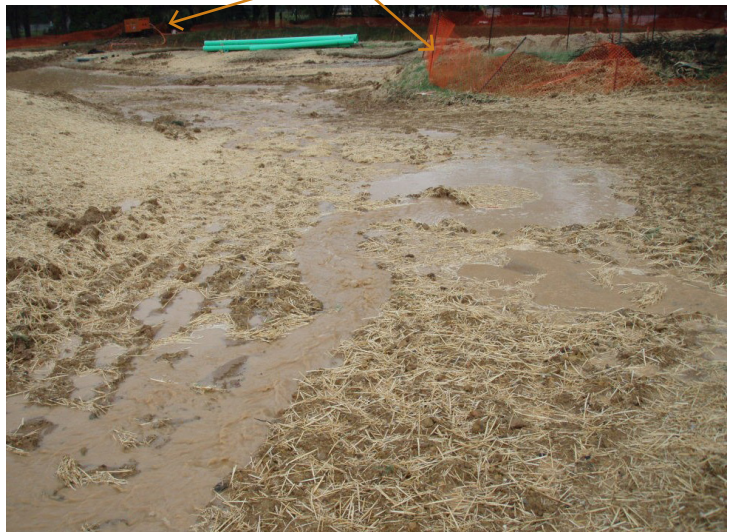
Figure 3

Another problem was the lack of linear sediment controls, evident in Figure 3. This is clearly a permit violation. Review of the SWPPP shows that wattle installation was scheduled to start on September 10, and yet all wattles on site were not properly spaced or installed (see loose wattles in the background) as of November 28.

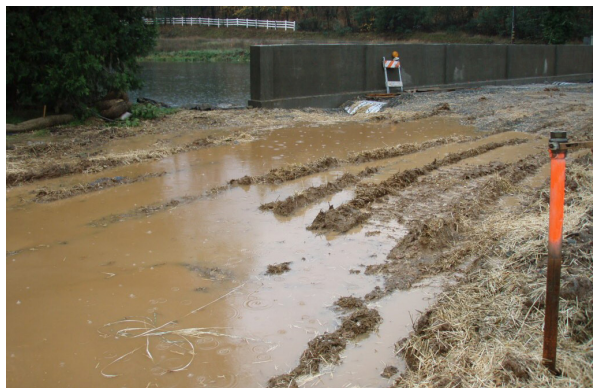
Figure 6

Then when the inspector followed up on November 28, discharge was observed from the site (Figure 6). Discharge does not necessarily equate to a violation. The violation in this instance was that the QSP claimed that no discharge occurred (Figure 7). This is falsification of compliance documents.

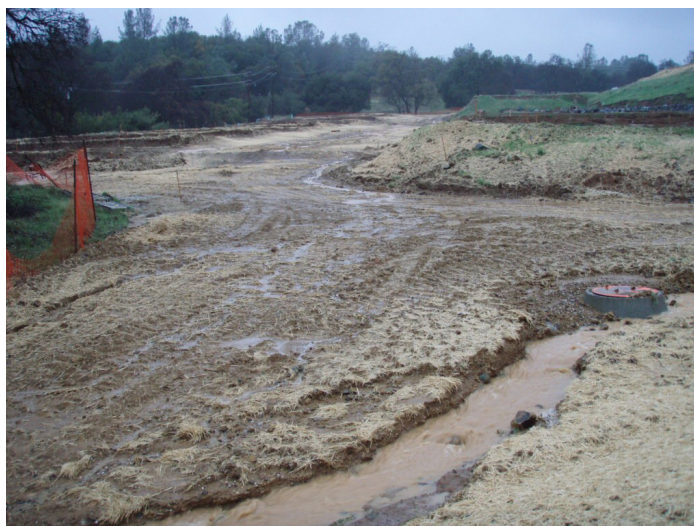
Figure 8

Remember that the Clean Water Act in Section 309(c)(4) provides that falsification of reports can result in fines up to \$10,000 and imprisonment for up to two years. In another storm on November 30, the inadequate BMPs were easily overwhelmed (Figure 8).

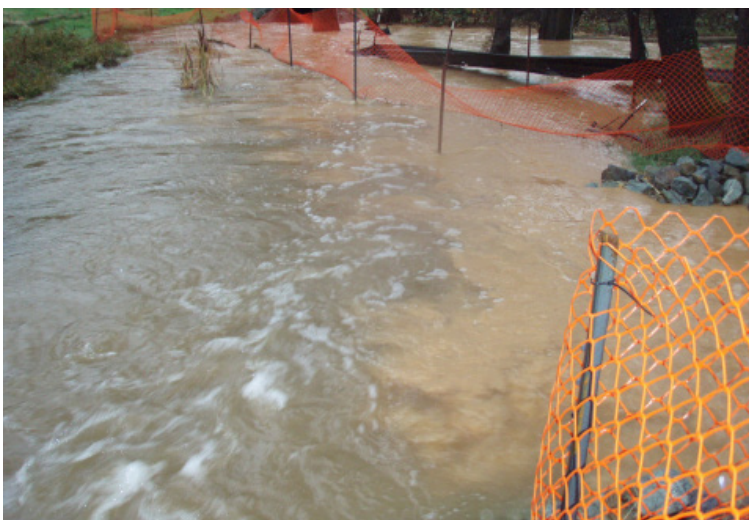
Figure 9

Further documentation of damage to the natural water quality of a creek (Figure 9) contributed to stiff penalties. Finally, an Active Treatment System (ATS) unit was brought in (Figure 10). Last minute implementation to fix big problems was not a very cost-effective solution. The ATS system alone cost over \$100,000, and other BMPs were still required to comply with the provisions in the permit.
