EVALUATION OF STORM WATER TREATMENT BY VEGETATED AREAS ADJACENT TO HIGHWAYS

International Erosion Control Association (IECA), 34th Annual Conference and Expo., Las Vegas, Nevada, February 24-28, 2003

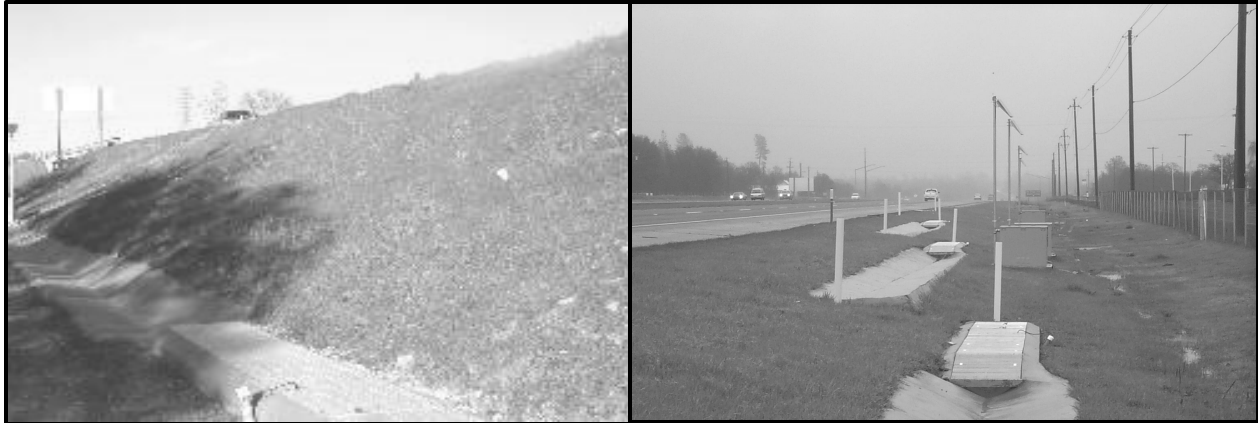
collection trench at each site captures storm water runoff at the edge of pavement. Test sites with slopes greater than 35 percent have one collection trench at the edge of pavement and one collection trench at the toe of the slope. A photograph of a test site with a slope greater than 35 percent is displayed on the left side of Figure 2. At the test sites with a slope less than 35 percent, one collection trench is located at the edge of pavement and the remaining collection trenches are located at intervals of approximately 2 m, 4 m, and 8 m from the edge of pavement. A photograph of a test site with multiple collection trenches is displayed on the right side of Figure 2.

Figure 2. Cottonwood and Redding Test Sites.
